**FIRE PERFORMANCE EVALUATION OF "SAMPLE 6EFWT LOW E," A
NOMINAL 1/4-IN. THICK *SCRIMLESS FOIL/POLYETHYLENE
FOAM/WHITE SCRIMLESS FOIL*, IN GENERAL ACCORDANCE WITH
THE 2006 EDITION OF NFPA 286, *STANDARD METHODS OF FIRE
TESTS FOR EVALUATING CONTRIBUTION OF WALL AND CEILING
INTERIOR FINISH TO ROOM FIRE GROWTH***

FINAL REPORT
Consisting of 20 Pages

SwRI Project No. 01.11811.01.420c
Test Date: June 6, 2006
Report Date: August 3, 2006

Prepared for:
Environmentally Safe Products, Inc.
313 West Golden Lane
New Oxford, PA 17350

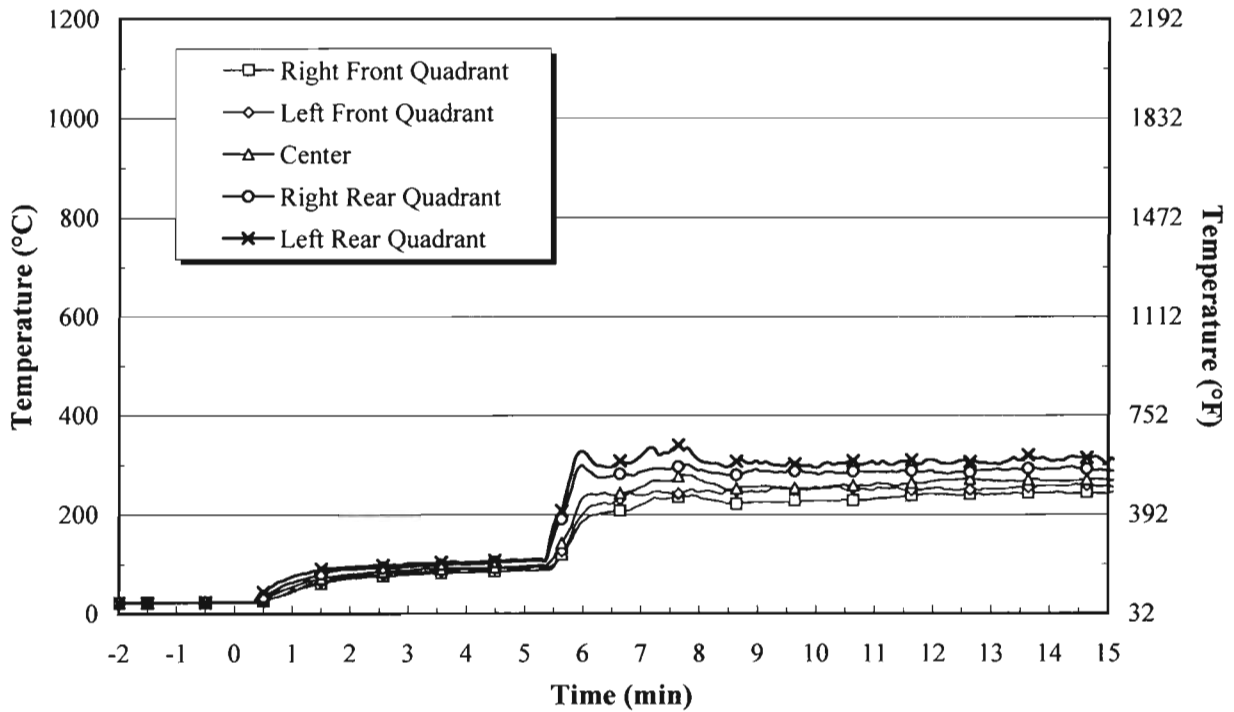
UPPER LAYER TEMPERATURES

Maximum HRR_{total}	261 kW	at	7 min 33 sec
Average HRR_{total}	158 kW		
Total Heat Released	142 MJ		
Maximum $HRR_{excl. burner}$	103 kW	at	7 min 33 sec
Average $HRR_{excl. burner}$	39 kW		
Total Heat Released (Excluding Burner)	35 MJ		
Maximum Smoke Release Rate	0.38 m ² /s	at	6 min 3 sec
Average Smoke Release Rate	0.20 m ² /s		
Total Smoke Released	181 m ²		
Maximum Optical Density	0.13 1/m	at	6 min 3 sec
Maximum Duct Flow Rate	1.30 m ³ /s		
Average Optical Density	0.069 1/m		
Average Volumetric Duct Flow Rate	1.30 m ³ /s		
Total Heat Flux to the Floor	2.1 kW/m ²	at	13 min 18 sec
Max. Average Upper Layer Temperature	280°C 535°F	at	7 min 48 sec
Maximum Doorway Temperature	246°C 475°F	at	7 min 43 sec

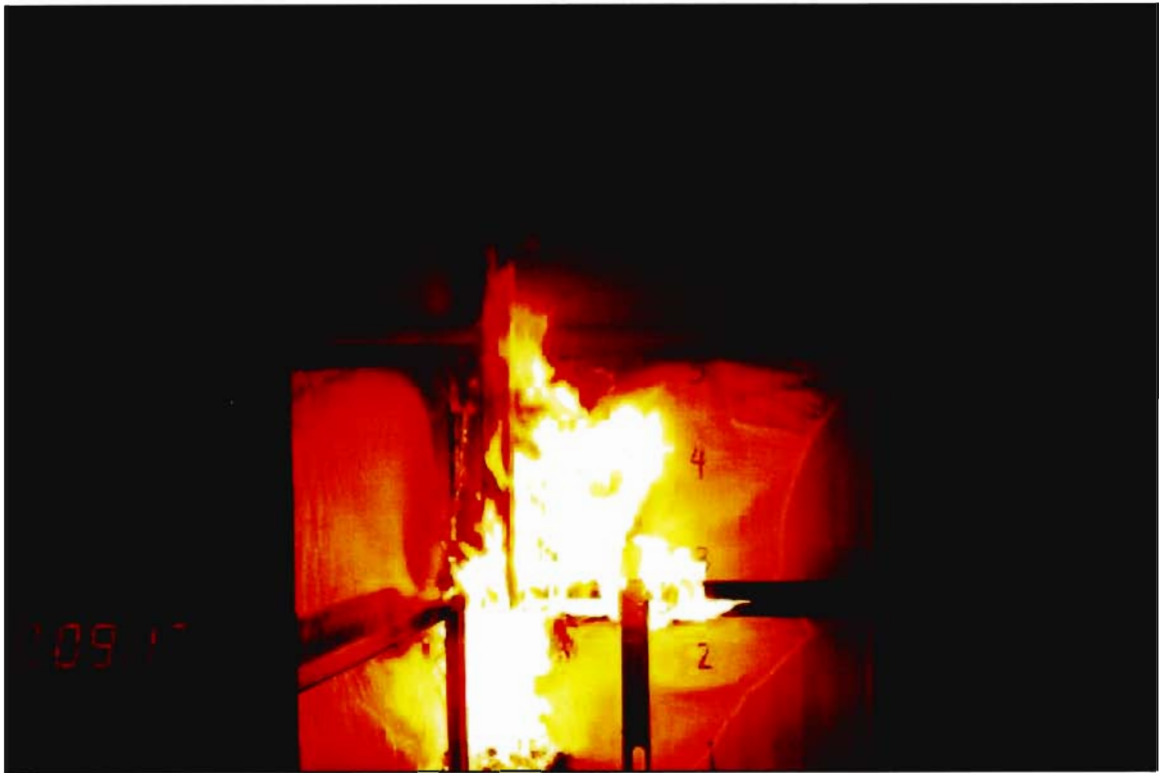
Figure B-5. Approximately 9 Min Into Test.

- 09:00 Flaming on the building wrap from the top of the burner to the underside of the second zee-purlin. Light grey smoke in the room interior down to 5 1/2 ft above the floor.

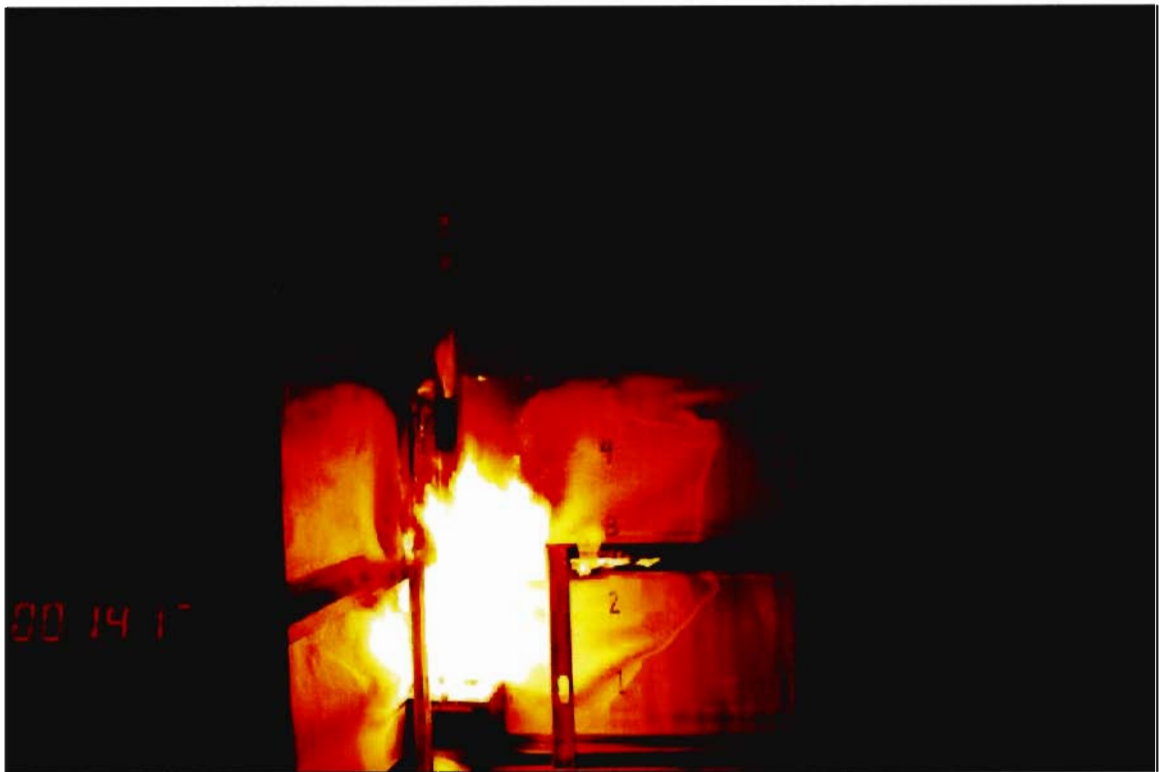
Figure B-6. Approximately 10 Min Into Test.

- 09:51 All surface ignition of the building wrap has gone out.
- 13:00 Flames in the burner corner are intermittently touching the ceiling. Damage to the building wrap is approximately 18 in. in width from the top of the burner to the underside of the first zee-purlin and approximately 24 in. in width between the first and second zee-purlin and scorching from the second zee-purlin to the underside of the ceiling.

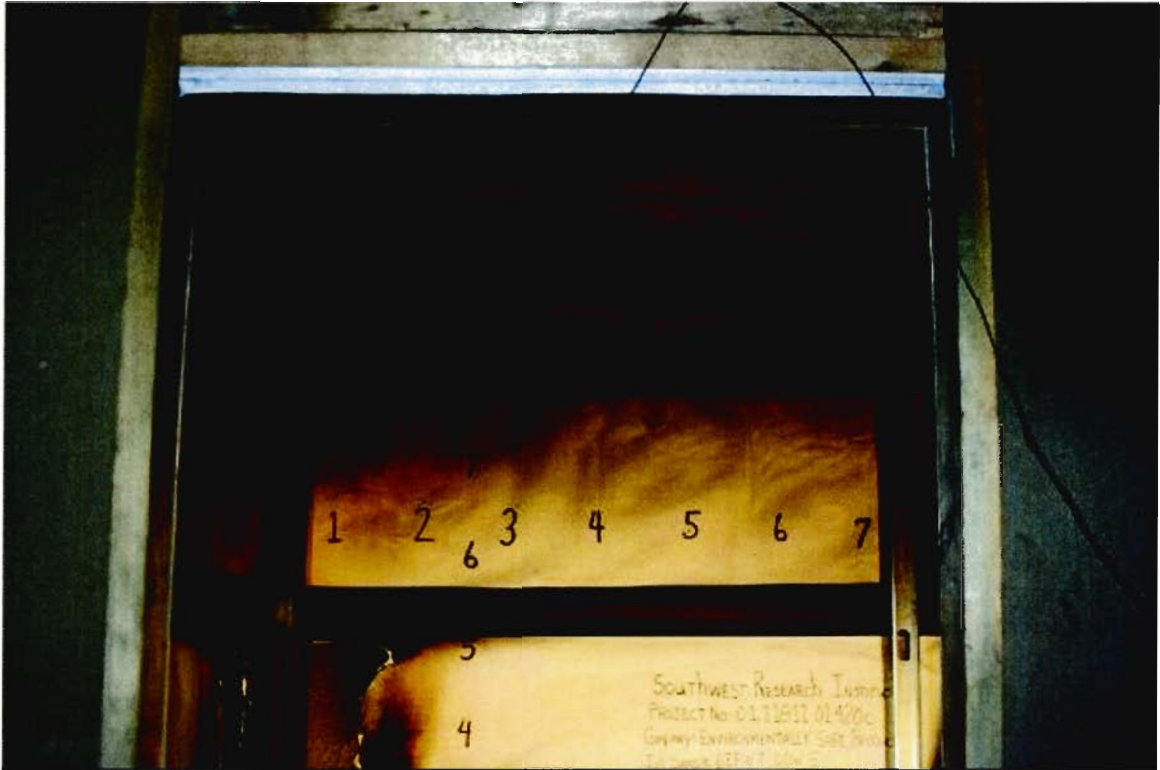
Figure B-7. Test Terminated. View of Room Interior, Back Wall and Ceiling.
